# HURRICANE ELENA STORM SURGE DATA

## Report 3

Coastal Engineering Research Center

Report 3 of a Series

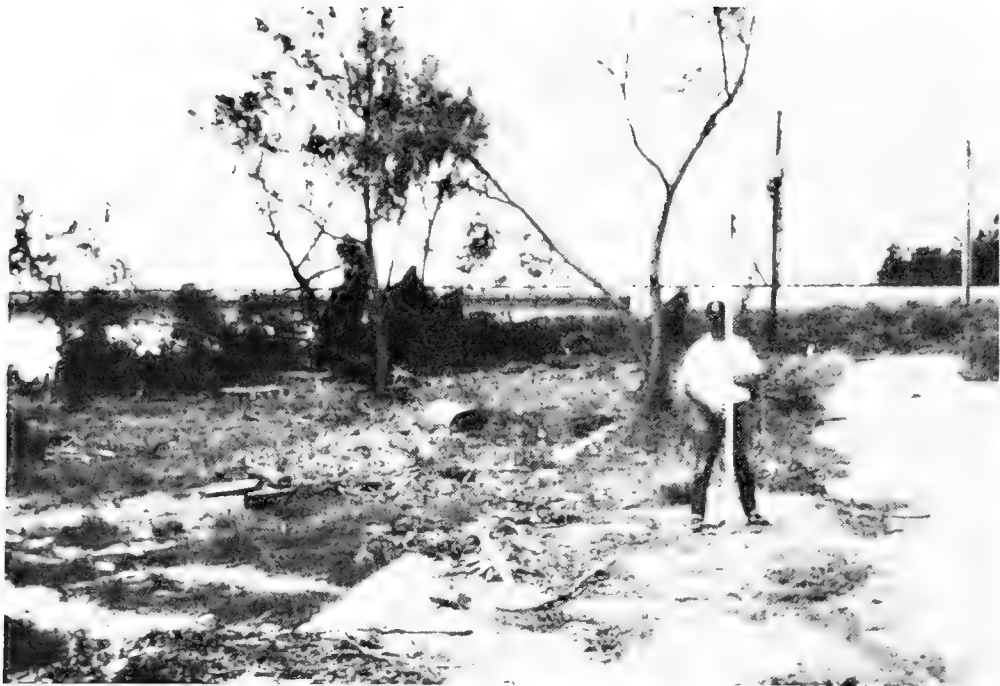
14. Trash lines remained all around the shores of Biloxi Bay. On the eastern side of the bay at the location of the Biloxi fishing bridge (the remnant of the old Highway 90 bridge), the surge washed across part of a shore-front road. Photo 1 shows this trash line being surveyed. The elevation of the surge induced flooding did not exceed +3 ft NGVD at this point.

Photo 1. Surveying debris line at the east end of old Highway 90 fishing bridge, Biloxi, Miss.

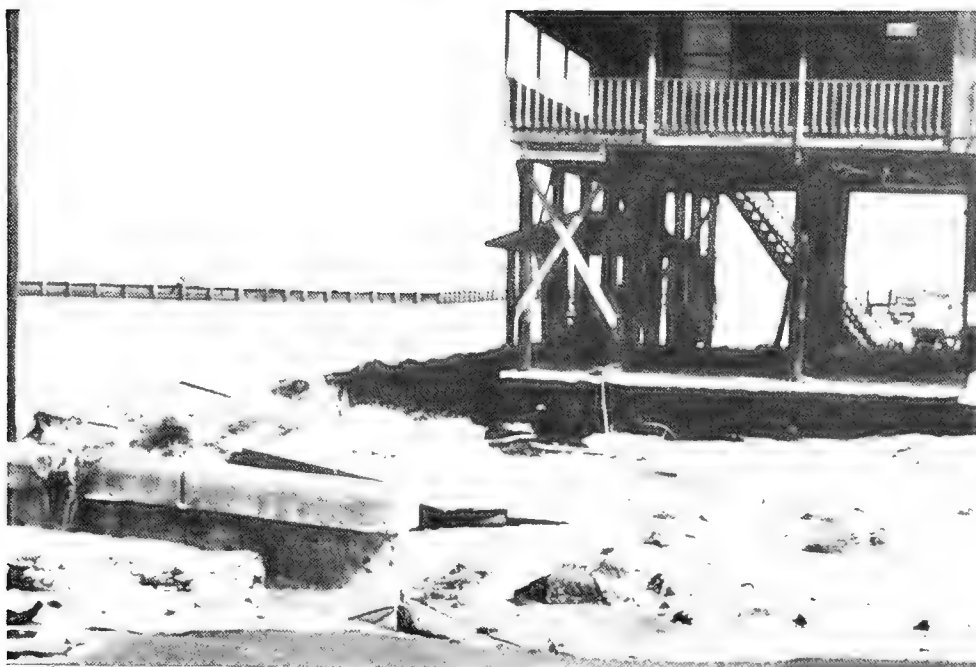
16. The hardest hit area on the coast was Dauphin Island, Ala., which was directly in the path of the hurricane's track just prior to landfall. There was extensive wind damage all over the island, but the majority of the damage caused by the surge was seen on the western half of the island where the surge passed completely over the island at a number of locations. This resulted in gullying which damaged roads (Photo 3) and undermined the foundations of houses (Photo 4). The high-water mark at these locations measured +6.5 ft NGVD. The small-boat harbor on the northeast side of the island suffered very little structural damage, but some of the boats were damaged or sunk when they broke free of their moorings (Photo 5). The only major surge-induced damage on the eastern end of the island occurred at Pelican Point where the deck of the wooden pier supporting the NOS/CE surge gage was destroyed (Photo 6). The high-water level at this location was about +6.7 ft NGVD with wave runup heights exceeding +8.0 ft NGVD.

Photo 4. Foundation damage on the western half of  
Dauphin Island, bay side

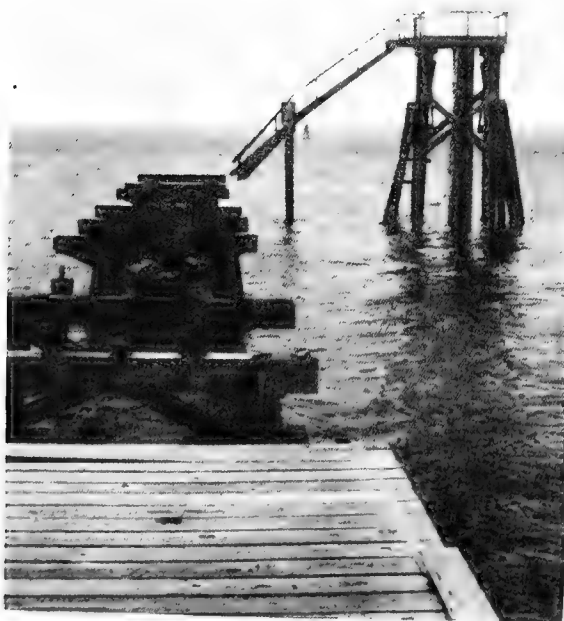
Photo 6. Pier damage at Pelican Point on the eastern end of Dauphin Island showing the NOS tide station where hydrograph of Dauphin Island (2) was obtained

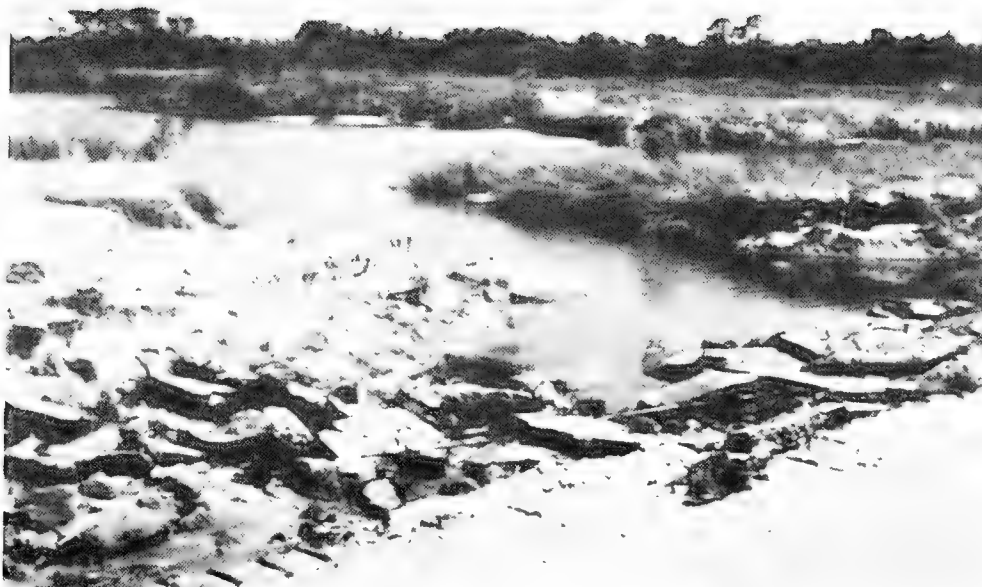
entrance to Mobile Bay exceeded +8 ft NGVD and reached the base of the seawall in Fort Morgan State Park (Photo 7). Within the boundaries of the state park, there were several locations where the surge passed completely over the spit, resulting in highway erosion (Photo 8). While surge related damage was confined to the highway, high winds totally destroyed one building and severely damaged several others in the park. Surge elevations dropped rapidly east of the park to an average of +4 ft NGVD. This was sufficient to cause some flooding in the communities located between the park and the city of Gulf Shores. However, the amount of structural damage was minimal as can be seen by the house shown in Photo 9.

Photo 8. Evidence of overwash resulting in road damage in  
Ft. Morgan State Park, looking north

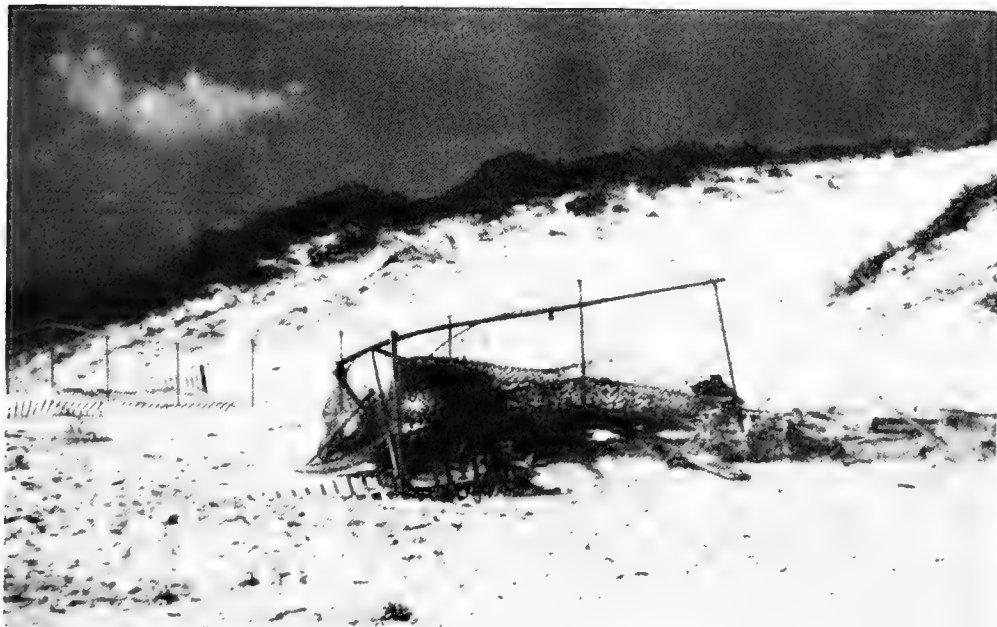
18. Throughout the western part of the Florida panhandle the measured high-water marks were less than +5 ft NGVD. Thus, actual damage resulting from surge was limited to minor highway damage and to structures located very close to the high-water mark such as the chain link fence in Pensacola Beach shown in Photo 10. In Destin, the surge and wave runup cut through a dune line (Photo 11) and flooded a lagoon located behind the dune line. The water level in the lagoon rose approximately 5 ft but did not flood any of the structures surrounding it. Farther east along the coast, surge levels continued to diminish with most high-water marks at an elevation of less than +4 ft NGVD. However, some damage did occur at several locations. One such location was the Dan Russell City Pier in Panama City Beach, Fla. The concrete decking on the end of the pier was lifted and broken by waves (Photo 12). This damage occurred at an elevation of approximately +20 ft NGVD, at a location where the measured wave runup did not exceed +10 ft NGVD, and is probably the result of the seaward end of the pier being in the breaker zone during part of the storm.

Photo 10. Damage to chain link fence in front of dune line at  
at Pensacola Beach, Fla.

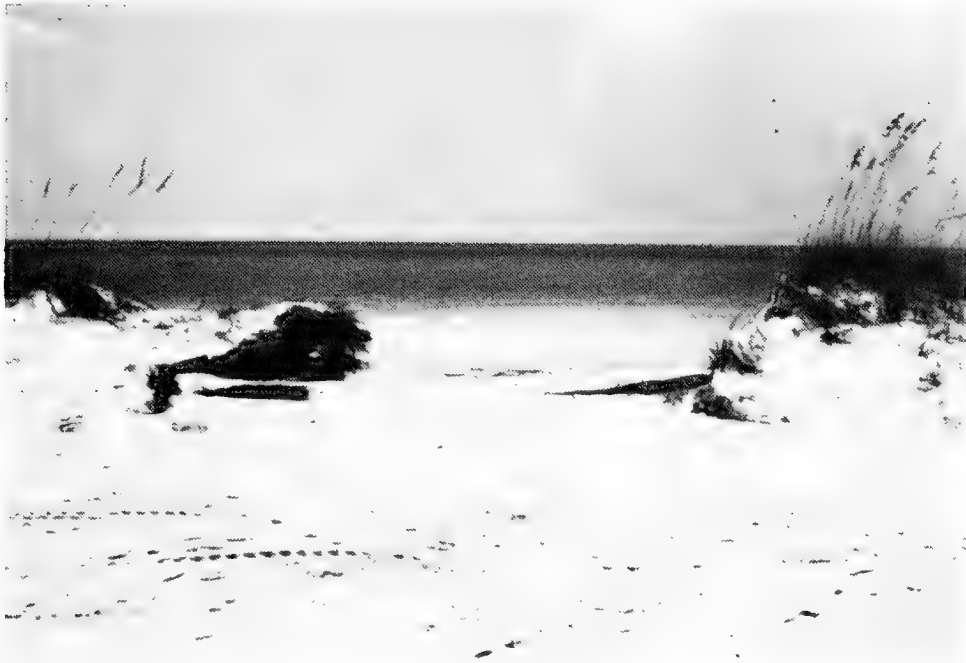
Photo 11. Cut through dune line in Destin, Fla.,  
looking south

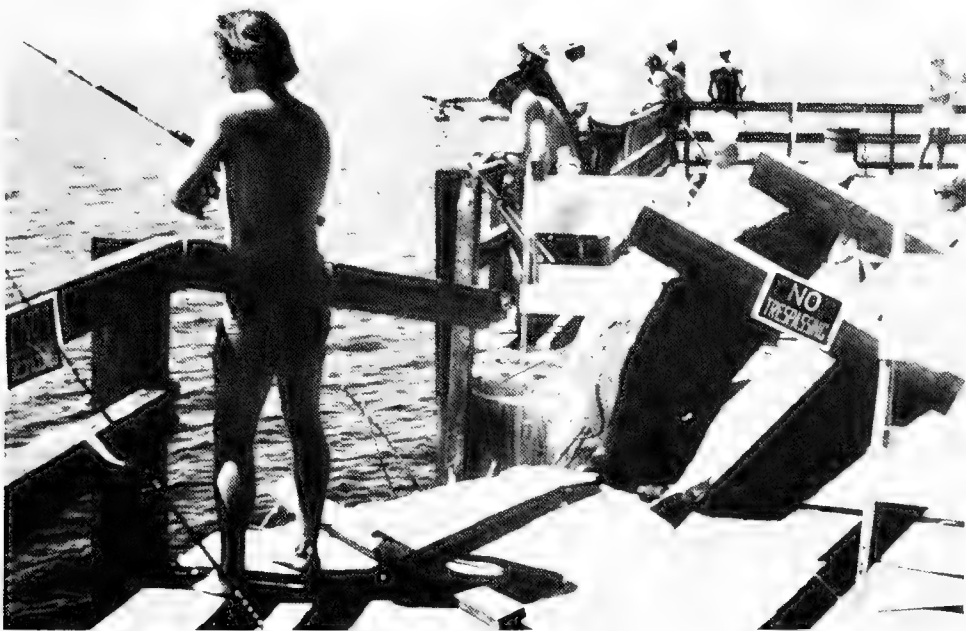
Photo 12. Damage to the decking of Dan Russell City Pier at  
Panama City Beach, Fla.
